Bostwick Creek 9 Key Elements Plan

La Crosse County

Department of Land Conservation

September 2018

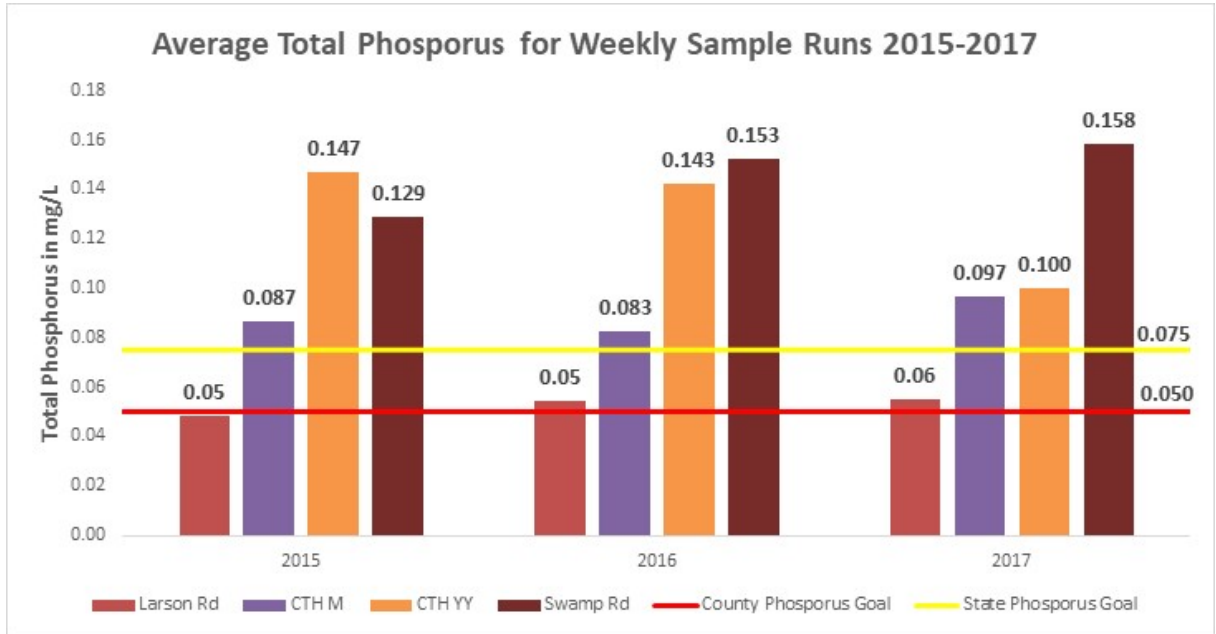
Graph 1. Average total Phosphorus weekly samples 2015-2017

Both graphs indicate that the water quality in Bostwick Creek degrades as the stream flows downstream. Both total phosphorus and E.coli bacteria quickly exceed the water quality goals set by the Department of Land Conservation at 1,000 colonies of bacteria and 0.05 mg/L of total phosphorus.

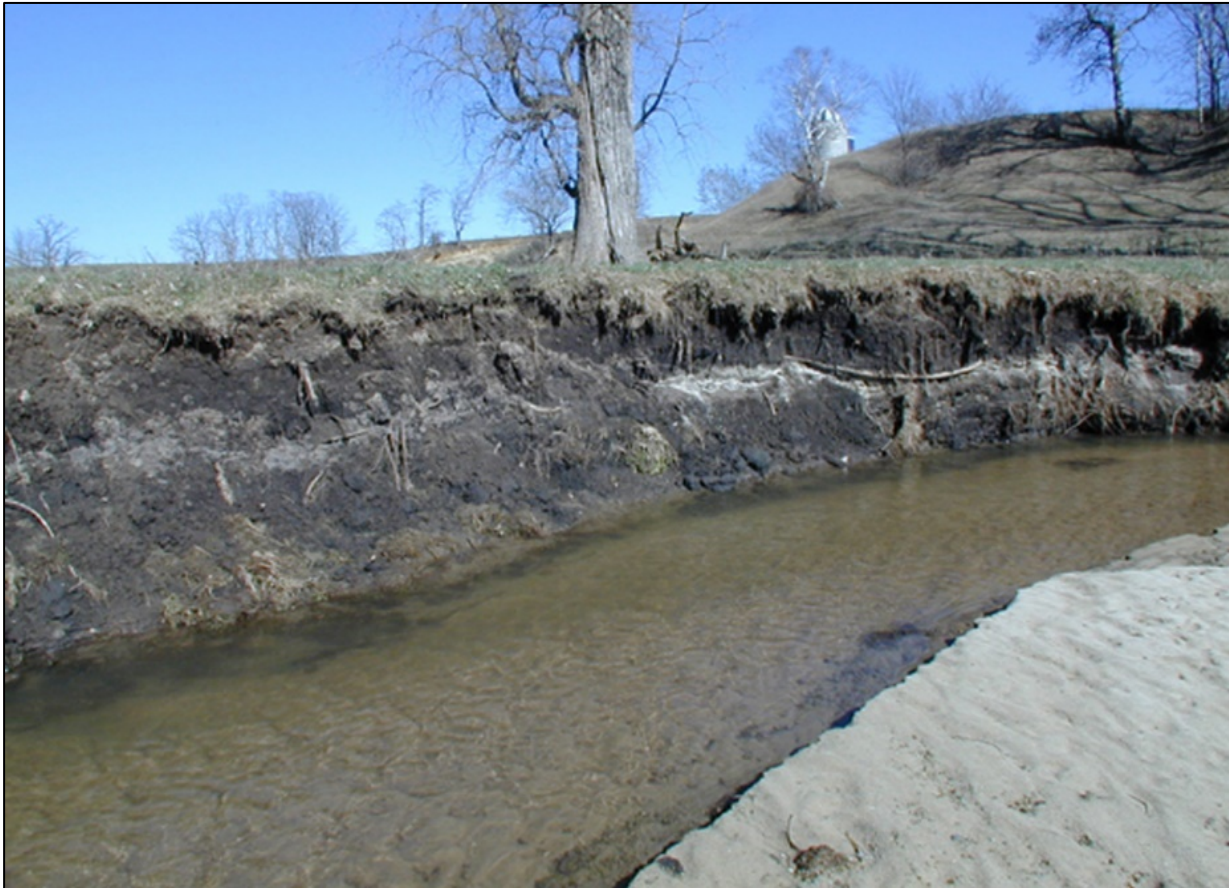
Figure 18 Streambank Erosion Photo

Streambank erosion is a common problem in the Driftless Region of Wisconsin. The steep, incised valley bottoms often contain several feet or more of deposited sediments from upland erosion. These streams meander extensively through these deposits as it flows down gradient. When intense rainfall events occur, the streams quickly swell and the force of the rushing water easily erodes the sediments from the streambanks. The STEPL model estimates that streambank erosion accounts for 8,213 tons of sediment per year and 10,806 pounds of phosphorus per year. The presence of cattle and unmanaged grazing practices along the streambanks also contributes to the acceleration of eroding sites. Eroding streambanks is the primary cause of excessive in-stream sedimentation that degrades fish habitat and other aquatic biota. See Figure 18.

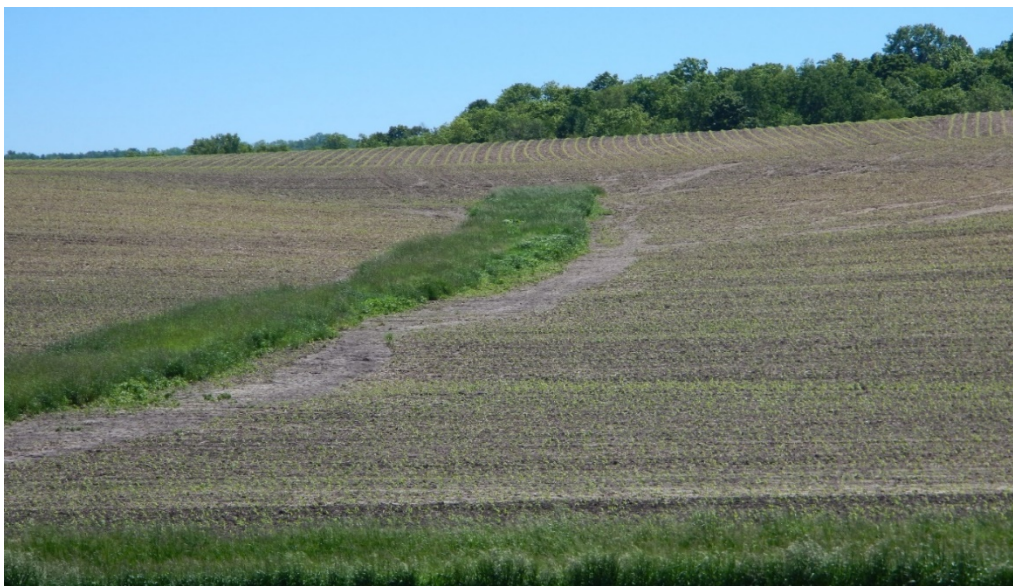
Figure 26 In-field Gully Formation Photo

Gully erosion in the Driftless Region of Wisconsin usually occurs in two forms. One type of gully formation occurs after heavy rainfall or snowmelt events and are referred to as ephemeral gullies. These can be seen in crop fields where erosion control practices failed to provide adequate protection against the erosive forces of a runoff event. These types of gullies often cause sedimentation to occur at field edges and road ditches. Often times this sediment is carried to nearby streams and degrades water quality. These gullies are typically repaired by the farm operator after crops have been harvested and may not reappear for years. See Figure 26

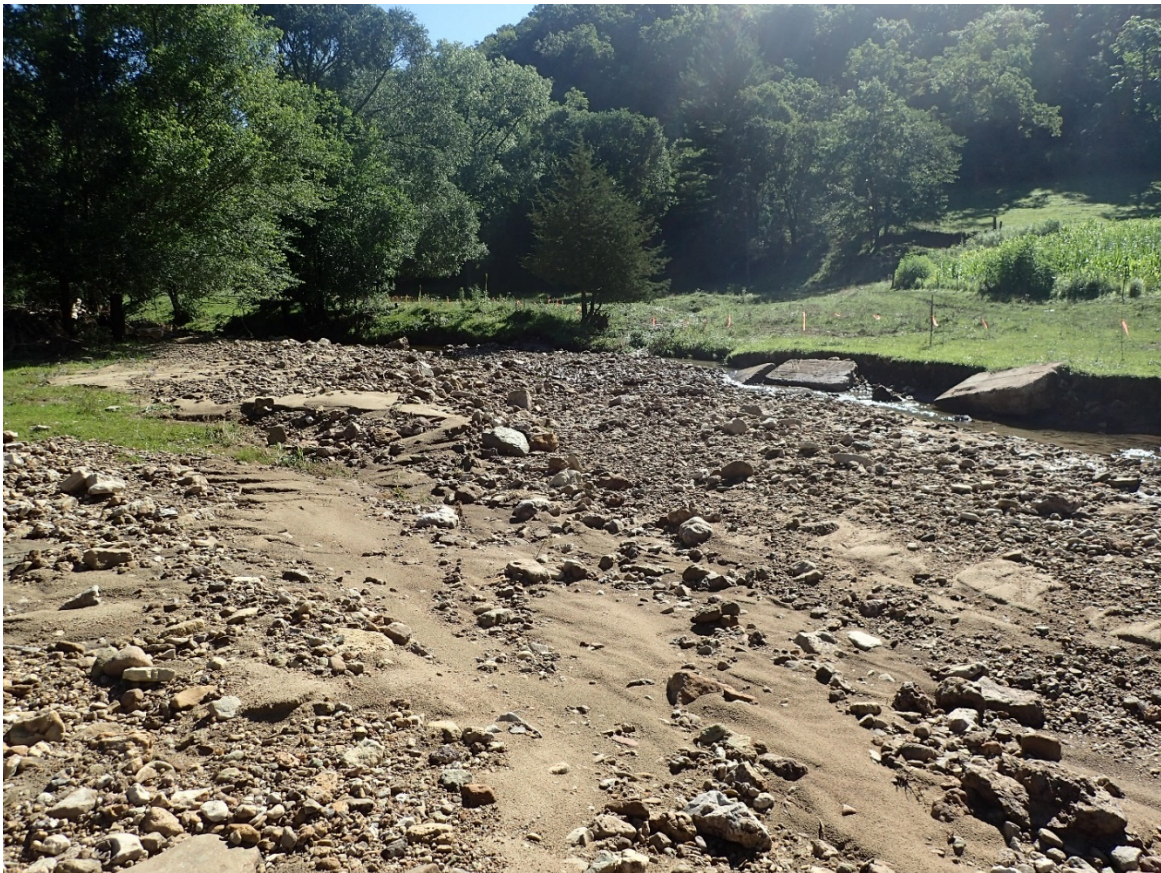
Figure 27 Dry Run Gully Deposits Photo

Under normal runoff events, these gullies are not considered to be active but rather serve as a conveyance system for runoff water from the uplands to the valley bottoms below. Under extreme runoff events, such as those that occurred in 2007, 2008 and 2017, these dry run gullies become raging torrents of water capable of transporting large boulders, rock and rubble downslope. These events can result in the littering of crop fields and stream beds with rock and rubble that have permanently redirected stream channels. See Figure 27

Dry run gullies are numerous throughout the watershed and their contribution to sediment loading under normal runoff events is questionable. During extreme runoff events, these gullies transport material at rates that exceed soil loss calculation models. Utilization of conservation practices on ridge top crop fields that promote infiltration and slows runoff rates are important to reducing the downslope impacts from dry run gullies.

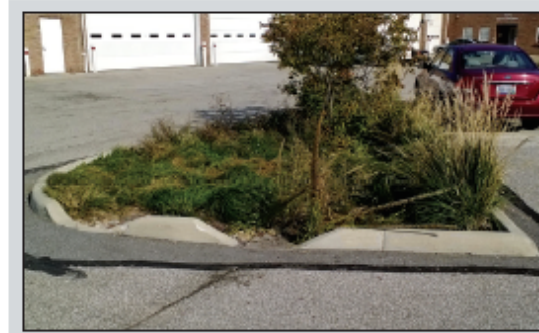
Parking lot rain garden.

Performance levels of vegetative structural practices—such as constructed wetlands, swales, rain gardens, riparian buffers, and filter strips—can be assessed using the following types of indicators:

- Extent and health of vegetation (e.g., measurements of soil cover or plant density),
- Quality of overland flow filtering (e.g., evidence of short-circuiting by concentrated flow or gullies through buffers or filter strips),
- On-site capacity testing of rain gardens using infiltrometers or similar devices, and
- Visual observations (e.g., presence of water in swales and rain gardens).

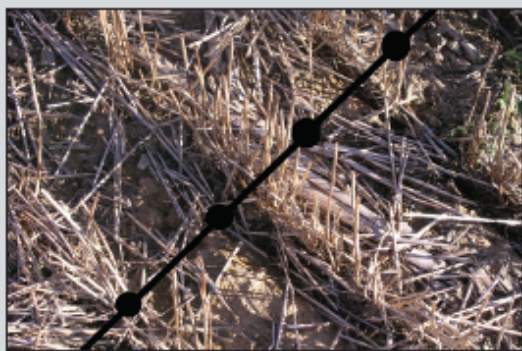
Illustration of line-transect method for residue.

- Extent of crop residue coverage on conservation tillage cropland, and
- Fertilizer and/or manure application rates and schedules, crop yields, soil test data, plant tissue test results, and fall residual nitrate tests.

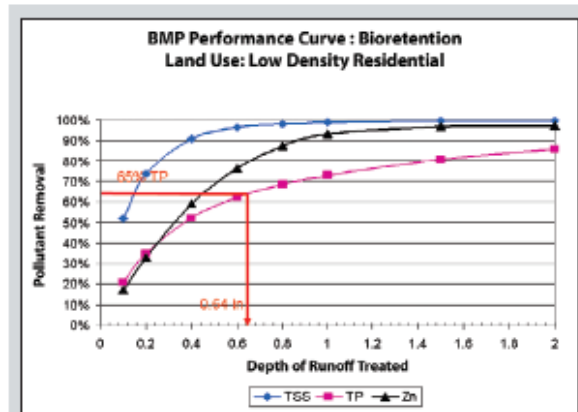
Figure 1. BMP Performance Curve for Bioretention BMP (Tetra Tech 2010).

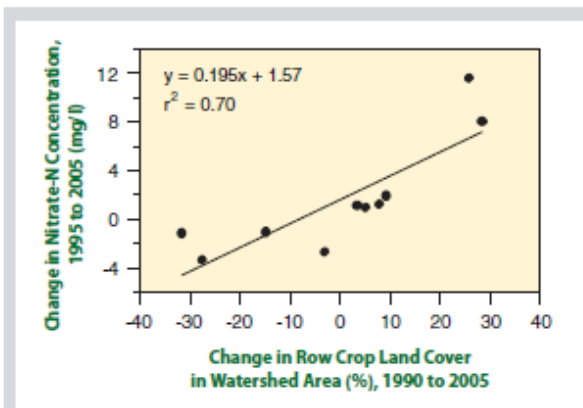
Figure 2. Relating Changes in Stream Nitrate Concentrations to Changes in Row Crop Land Cover in Walnut Creek, Iowa (Schilling and Spooner 2006).
